Care and feeding: Shinn Brakes

By Rob Lees

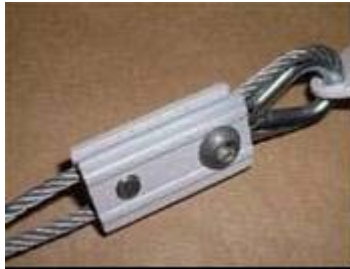
Figure 1 “Bug”

Cables are attached to the pedals by passing them through and clamping off. I have seen several methods for clamping, including the “bug” (Figure 1), clamp plate (Figure 2) and cable grips (Figure 3). Note the heat-shrink tubing to secure the cut cable end.

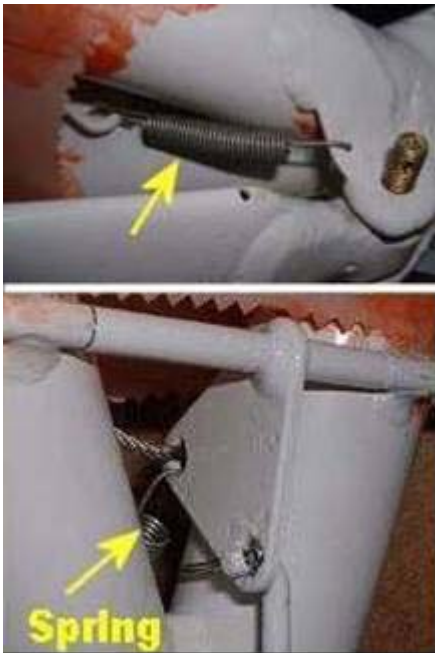
Figure 4 Two views of bellcrank spring

A spring at the bellcrank (Figure 4) maintains tension on the cable, so reducing the lost motion (backlash) of the cable.

The brake cables should be in sufficient tension to *just* not pull on the bellcrank. The cable is held in tension between the pedal stop in the cabin and the bellcrank spring in Figure 4. The clamps at the pedal end of the cable can be adjusted to take up excessive slack. I have seen some cables with turnbuckles used to adjust the tension.

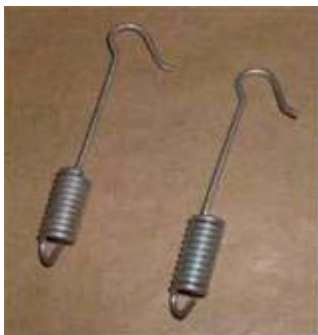
Figure 7 Return springs

Return springs (Figure 7) pull the shoes off the drum after braking.

Check the return springs (Figure 7) to ensure they are not broken.

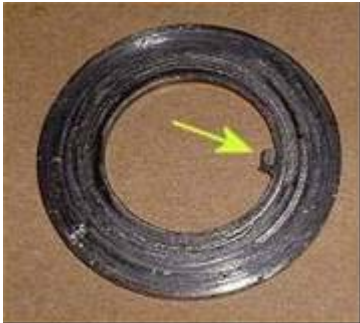
Figure 9 Tab washer

The washer has a locating dog on the inside which fits in the slot in the axle (Figure 9).

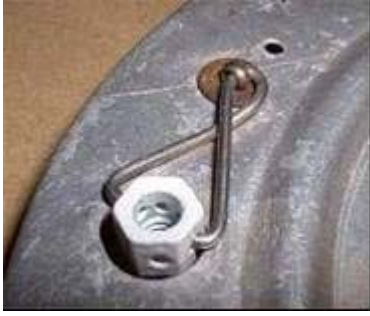
Figure 11 Locking clip

The adjustment nuts are safetied with little wire clips (Figure 11). Mine are stainless.

The adjustment wedges (figures 8 and 10) are adjusted by tightening the nuts on the brake backplate (figure 11). Adjustment should be done equally on both wedges of the wheel. This moves the fixed end of each shoe closer to the drum. An approximation of the correct “tightness” of the brake is when the tyre *just* cannot be turned by hand when an assistant presses on the pedal, but they should spin freely with no brake applied. Spinning the wheel by hand and applying the brake to stop it will ensure the shoes are centred correctly within the drum.

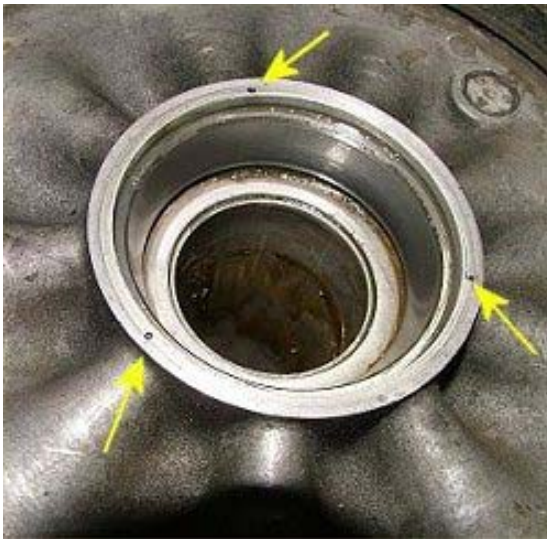
Figure 12 Staking marks

If replacing the outer races, ensure they are staked properly. We have used Loctite "bearing fit" in the past too.

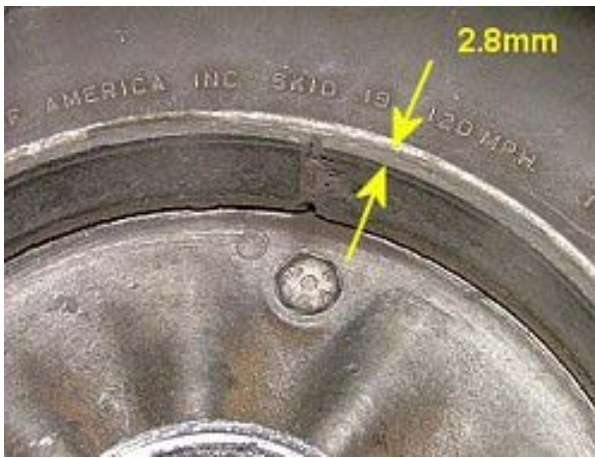
Figure 15 Lining wear

In September 2007, after three years, some 450 hours (and countless landings), the linings have worn by 0.2 mm.

Assuming that the linings are “worn out” when they reduce by a total of $\frac{1}{3}$ (i.e. 1mm of wear), then these linings should last for a total of 2250 hours [15 years] (or another 1800 hours [12 years] at current usage rates).

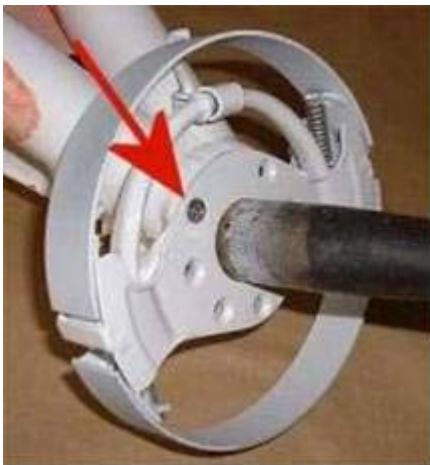
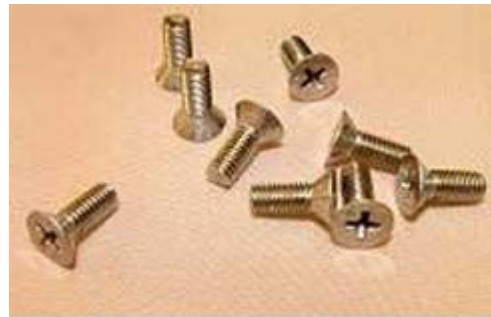
The brake plate assembly is screwed to the gear leg using unusual 82° countersunk screws. It would appear that the original slotted screws are not available, but I found a source of cross-head screws in stainless from an approved source.

The part numbers for the approved, stainless structural countersunk screws is MS51960-65 (or 10-32 UNF-2A x 1/2 PH FLT HD Machine Screw)
