BC12D Inspection ring approximate locations

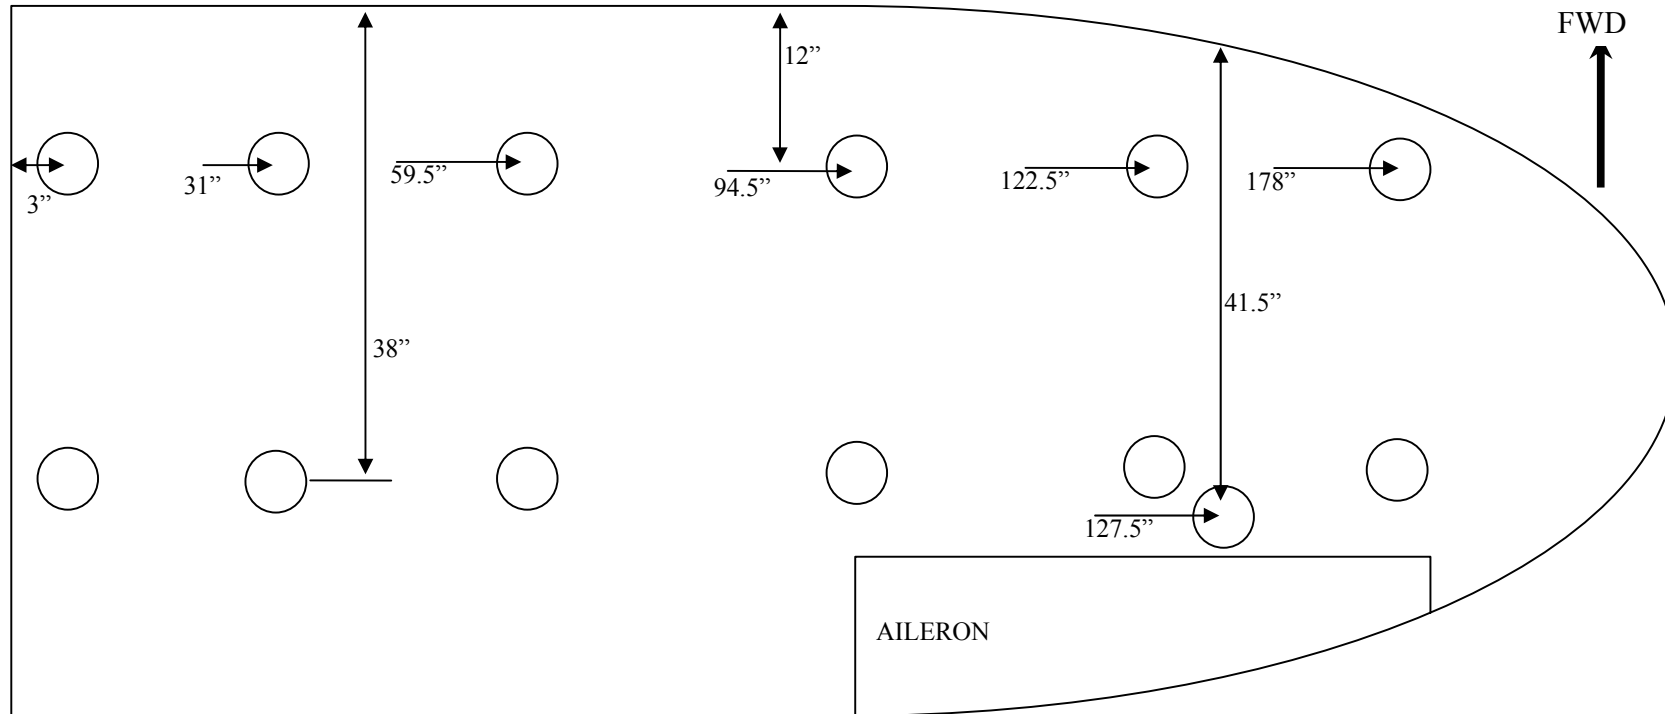
- This is a view of port wing from underside; stbd wing will be mirror image.
- Locations are approximate
- Based on 15-rib, 36-ft span, 6 compression rib, flapless models.
- Two rows of 6 rings are at the compression strut/spar intersections for inspection/adjustment of drag & antidrag wires.
- One ring beneath aileron actuator mechanism for inspection & lubrication.
- Some models (e.g. welded steel aileron brackets, rather than the cast type) will also require inspection hatch on top surface for lubrication of aileron bellcrank. This info not included.
